Lessons Learned

Project: DEN Concourse B West Expansion

Incident Title: Chain Fall Assembly Slips from Beam

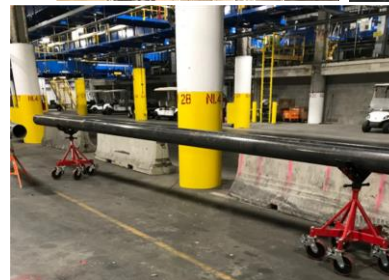
Raising 10 sch 40 pipe from jack stands into basement ceiling, required 5 chain falls. 4 were attached to uncoated beams, and the 5th chain fall was attached to a beam with monokote on it.

Multiple pieces of fab had been raised to the hangers in the ceiling previously without incident. While operating 5 chain falls at the same time by 5 crew members and raising the pipe from the jack stands approximately 2", the chain fall/ beam clamp assembly that was attached to a beam with monokote slipped off beam. Luckily the employee only took a glancing blow to the arm and leg from the chain fall and did not require first aid.

- PTP did not go far enough "into the weeds". Did not address verifying monokote removal to ensure complete contact of beam clamp to steel beam.
- Did not verify monokote removal.
- "Dry run" day prior, hazard was still missed.

- Just because similar tasks were completed without incident, doesn't mean all hazards were identified, eliminated or controlled. Don't get complacent, be diligent in the PTP process and following the steps to eliminate or control the hazard.
- Crews PTP "gets into the weeds"/ more specific, i.e. monokote removal down to steel so clamp seats properly and verification of this step is identified.
- Complacency and lack of verification can lead to something much worse than this lesson shared.
