Lessons Learned

Project: Larimer County Jail

Incident Title: Near Miss – Core Drilling with Embedment

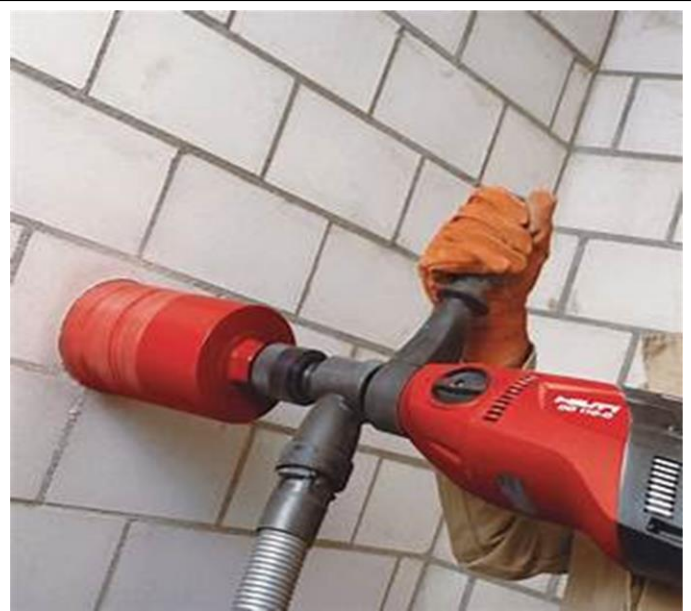
A sub of Apollo was planning a core drill for a 6" domestic water hole in the 2nd floor mechanical room. A layout was followed, highlighting where to drill, and a GPR scan was performed. The GPR scan showed embedment's in the wall, however, drilling was still performed. Roughly 3" into the wall, a spark was seen by the driller and though the bit was instantly removed, conduit line had been penetrated, resulting in a loss of power to existing air handling units within the facility.

- Thou GRP scanning was completed, and embedment's were clearly shown, drilling still occurred.
- Decision to drill was based on assumption that object was safe to cut.
- Protocol for what to do when GPR scans show unknown objects was not understood.

- **When drilling into CMU wall, scanning needs to be completed and layouts must be adjusted depending on the scan results, based protocol established and understood by all involved.**
- **All embedment's seen on any scan need to be identified as something that can be safely cut.**
- **Even rebar, should not be cut, unless structural integrity is not compromised by doing so.**
- **Possible conduit or electrical must be positively ruled out before any drilling or cutting takes place.**
