Lessons Learned

Date: 11/10/2021

Project: Microsoft

Incident Title: Faulty Hanger Tree

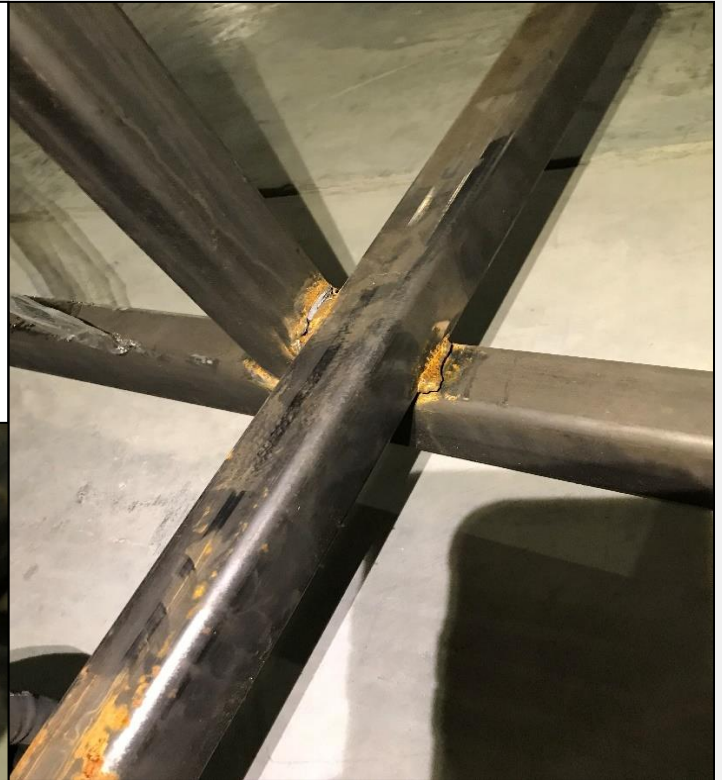
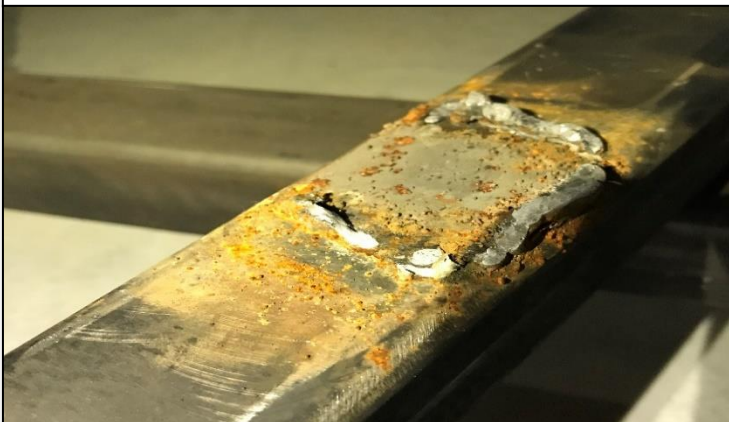
A forklift was used to unload the hanger tree and picked the load from the top. This caused a failure at the weld location. A considerable amount of the welds showed a lack of penetration and appeared to be surface level bonds.

- Welding conditions not conducive to quality fusion
- Insufficient QC of welds prior to arriving on site
- Inadequate/lack of pick points

- Utilize apple crates or basket carts that are engineered to support the intended load
- Hanger cart prototype will be crane compatible and specifically engineered with pick points
- Welds to be inspected by a competent person and identify/remove deficient items prior to delivery
