# Lessons Learned

Date: 1-12-22

Project: Hitachi BaT

Incident Title: Why we have Pressure test procedures-Near Miss

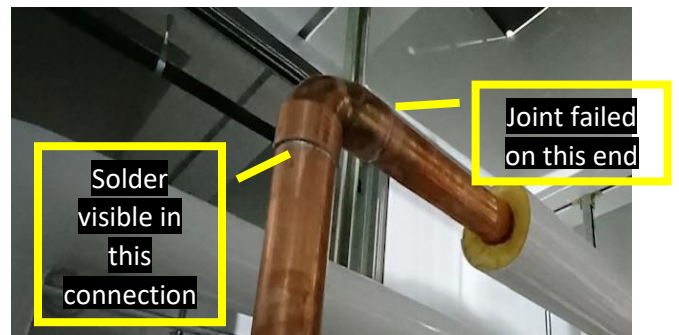
During the increase in pressure, it was noticed that the system was losing pressure. Further investigation revealed a 90-degree fitting that was leaking air.

While positioning to get a better look at the fitting, the fitting connection failed, causing a loud “pop”.

- Solder joint was not properly assembled causing failure.
- Loud pop could have created permanent hearing damage.

- Following test procedures requires diligence and expertise.
- There are no shortcuts to completing this dangerous task, that we do each day.
- AISH 41 is the guideline, with checklists and procedures to protect you, the system and facilities from damage.
- Shortcuts or failure to follow procedure can be life changing.
- Good job by the team to follow the procedure, and practice proper caution working on pressurized lines.
