Lessons Learned

Date: 01/17/2022

Project: Tesla C Building

Incident Title: Pipe Penetration

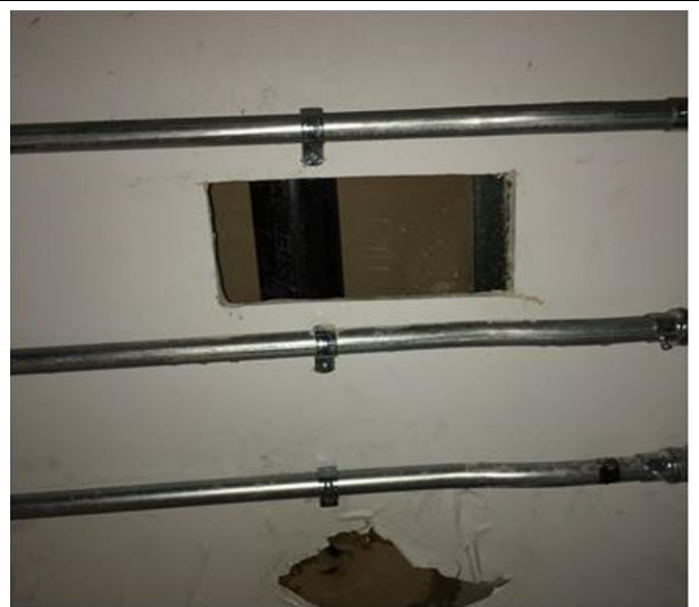
Apollo employee was drilling small holes into dry wall for studs to mount Unistrut for hangers. Upon drilling into the drywall, employee hit what was thought to be a stud, but was a fire water riser, penetrating the pipe. Though a stud finder was used, pipe was adjacent to the stud, mistaking a pipe for a stud in the wall. Water released for several hours while facility attempted to shut it down, resulting in pipe and drywall damage.

- Stud finder was used, but adjacent pipe was mistaken for a stud
- Employee hit a block, but switched drill bit to 1/8" and continued to drill
- Facilities did not fully shut water off for a few hours after the incident

- Only drill when needed, review task with foreman to ensure drilling is the only option
- Inspect contents inside wall / use stud finder
- Utilize stud finder data to identify clear spot / no stud or object in wall, that will be drill location
- Verify piping locations in drawings & specs, confirm with stud finder
- Switch to different anchor style / no drill bit drilling
- Use toggles in sheet rock wall clear spot instead of tech screw in stud.
