OH Schit...

Date: 5/26/2022
Project: UPF

Region: V Division/ TN
Incident Title: Dropped Support
Near Miss

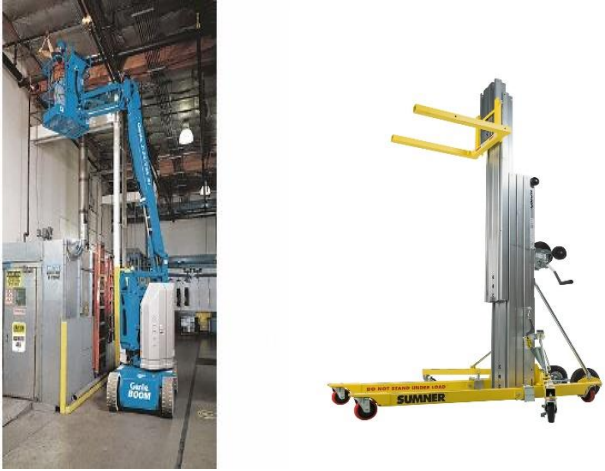
Summary	Picture
<p>Two Apollo employees were tasked to place a 10ft section of tube steel (weighing 210 lbs.) onto steel building trusses for it to be tack welded into position for installation.</p> <p>One employee planned to utilize a panel cradle attachment on an aerial lift to lift the tube steel material into place. Once they were in the air, they attempted to transfer the material from the aerial lift to a fully extended duct jack. After this transfer had begun the crew quickly realized that they needed another clamp to secure the tube steel.</p> <p>The individual on the ground let go of the duct jack to get another clamp, once this positive control was lost the duct jack shifted, causing the piece to fall approximately 23 feet to the floor below.</p>

What Went Right?	What Went Wrong?
<ul style="list-style-type: none"> • The area was barricaded and the material fell within the drop zone that was barricaded off. • The employee on the ground just left the area, ultimately being safe from the overhead fall. • The individuals immediately stopped work and informed supervision of the incident. • Individuals were forthcoming and honest during the investigation. 	<ul style="list-style-type: none"> • Working without Authority • No management oversight • No planning for this task (STARTR CARD) • Duct Jack wheels were not locked and only one outrigger was deployed • The material was not tethered during the transition. • Change in process. Similar work had been completed twice before using rigging and a chain fall. The crew decided to try a new method in an attempt to save time. • The employee on the ground was exposed to an overhead hazard due to the fact the material was not secured 100%.

Would of, Could of, Should of	
<ul style="list-style-type: none"> • Management should have been involved in the planning process. Especially if there was a change. • A planning session needed to occur before attempting this task. • Rigging should have been utilized to complete this task. • The ground individual should have exercised their stop work authority when they were concerned about the process.
