Lessons Learned

Date: 11/26/2022

Project: Redwood

Incident Title: Struck-by part of a Pipe Union

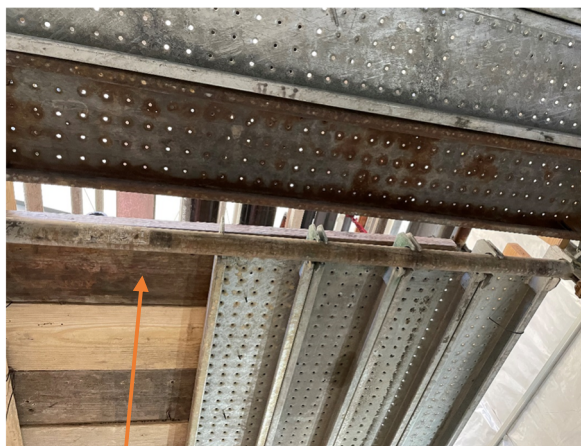
An Apollo Family member, Andrew Parker, was disassembling a 1" metal pipe union when he dropped the center piece of the union. The pipe union bounced off the end of a scaffold pick, then fell through a gap 6" between the scaffold picks and struck the Redwood Engineer standing approximately 8 feet away from the gap.

The scaffold erectors did not follow the proper procedure for scaffold erection, nor did they pay attention to details when erecting the scaffold.

- Gaps > 1" were left between the scaffold picks.
- Toe boards were not installed at the ends of the scaffold picks.
- The daily inspections of the scaffold are not thorough enough to notice the OSHA violations listed above.

- Cover the gaps between the scaffold picks prior to commencing work.
- Hang barricade tape and signage below the scaffold.

- 1) Take the time required to complete a task. Do not hurry.
- 2) Prior to taking over an area from another contractor, the Safety professionals shall facilitate a safety inspection.
- 3) Apollo family members shall inspect the area they are about to work in. Note & mitigate hazards in the area and within the process. Listing hazards on the PTP is only part of the plan to remain safe.
- 4) If it does not look safe, it probably is not. Ask questions about the environment you are about to work in. Install barricades as necessary.
