OH Schit...

Date: 1/24/2023	Region: Industrial
Project: Boardman LW Outage	Incident Title: Surprise Asbestos

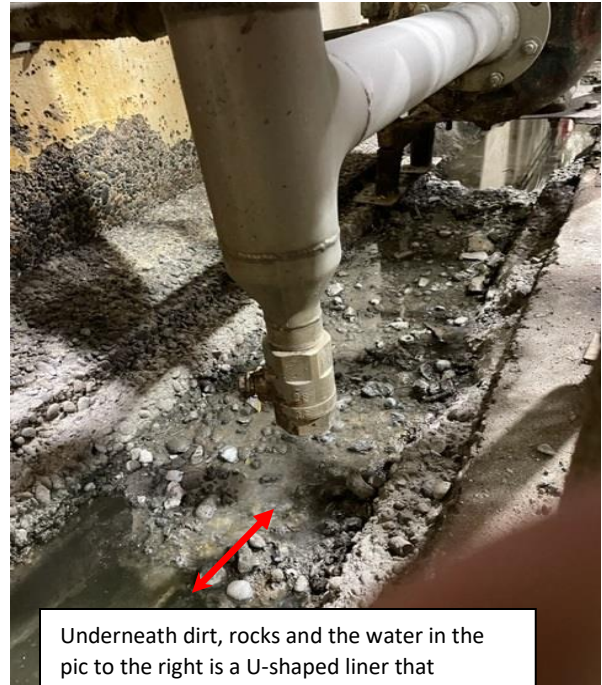
A crew was starting to demo a concrete flume in a customer's process facility. They were using a jack hammer in the area due to limited room to get a concrete saw in area. Scope was to demolish 70 ft. run of flume however within 10 ft. into the work the supervisor noticed that there started to be a liner in the flume that looked different than the other cement. It was a "U" shaped liner that was in bottom of the old flume, that flume had been filled with dirt and rocks. Upon seeing the different concrete and with his experience and knowledge he was certain it was a lined with asbestos. The supervisor immediately stopped work and cleared the room and notified the customer and Apollo Safety.

Underneath dirt, rocks and the water in the pic to the right is a U-shaped liner that contained asbestos.

- It was not called out in pre job walks or a known asbestos area by the owners.
- No asbestos report was provided.

- Ideally an asbestos report would identify any potential exposure concerns before demolishing of a project begins. However, with some older facilities the owners may have limited knowledge of where asbestos may be, therefore if we are doing any type of demolition work on facilities older than 1978, then we should train our employees on asbestos awareness.
