Lessons Learned

Date: 3/1/2023
Project: ADI 24k

Region: JB Southern Division
Incident Title: Pinched Pneumatic line in strut

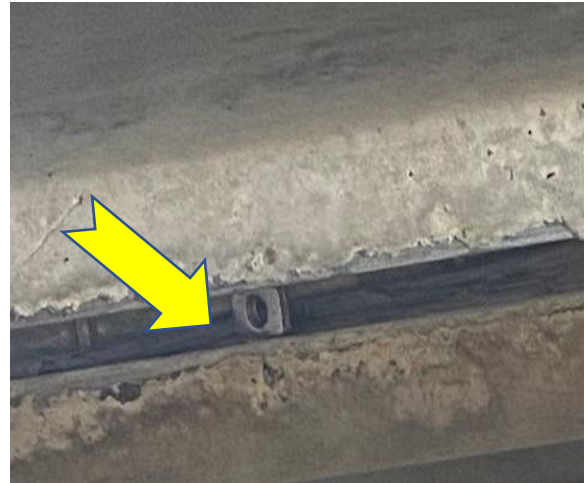
Picture

While installing hangers, worker pinched a pneumatic line with the strut nut. Once the strut nut became jammed in the strut, the pneumatic line started to make an air leak noise. There were several hangers installed in the same strut with the same line in it. It was not identified as a hazard prior to the work starting. This line did not impact the facility and it was not hooked to the HVAC system at the time of incident.

- Employee didn't notice pneumatic line install in strut prior to work.
- The hanger team had installed hangers next to line with out incident.
- No one reported the line being in the strut.

- Double check strut for utilities that were ran inside the strut. .
- Verify routes are clear prior to install.
- Team verified strut and found electrical running inside the strut as well.
