Lessons Learned

Project: Rocky Mountain Labs

Incident Title: Pressurized Line Cut Into

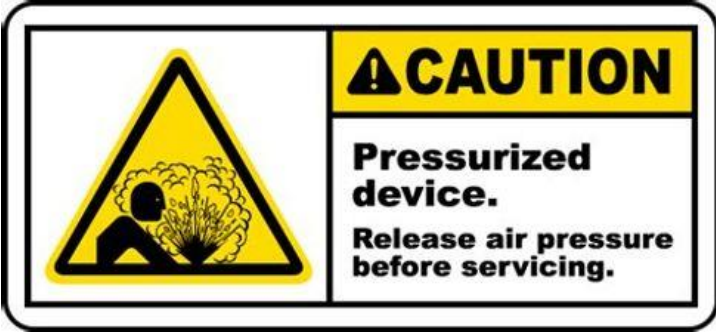
Summary	Picture
<p>Click or tap here to enter text..</p> <p>An Apollo employee was working with his supervisor and pressure testing two systems at one time. The systems ran parallel to one another. During their pressure test, Apollo was notified that the lines needed to be modified as they were interfering with the design of the ceiling. The employee performing the pressure test went and bled down the systems. The employee thought both systems had been depressurized, however when he went to cut into a 2" copper line with a Milwaukee auto-cutter there was a loud noise, and his tool was kicked back into his left knuckle leaving a minor laceration. The employee immediately realized only one system was bled down and forgot that the final line he cut into was separate from the first 3 lines, and consequently was still pressurized at 100 psi. The employee suffered a minor cut but the "Oh Shit Factor" was very high. During the investigation it was found that the Apollo team members were missing key elements from our AISH 41 Flushing and Pressure Testing Procedure while performing pneumatic tests.</p>

What Went Right?	What Went Wrong?
<ul style="list-style-type: none"> • Apollo had a test header installed and pressure relief valves during pressure testing. • Pressure test certificates were being produced and used. • Initial crew performing pressure testing was trained. 	<ul style="list-style-type: none"> • Apollo did not have tags identifying which systems were under pressure • Testing area was not barricaded and allowed for other trades to be inside of the recommended safe distance determined by calculation. • Information was not communicated up and down the flagpole. Miscommunication from management to field and vice-versa.
Lessons Learned	
<ul style="list-style-type: none"> • Re-training is to be completed with all individuals involved in pressure testing using the Apollo AISH 41 procedure. • Direct supervision is to be maintained during the pressure test. • A 24-hour notice will be required to be given to all trades in the affected area, so that the testing can be done without unnecessary exposure • Area will be barricaded the appropriate amount of distance back with signs indicating pressure test being performed do not enter.
