Lessons Learned

Project: North Valley Complex

Incident Title: In HOT water

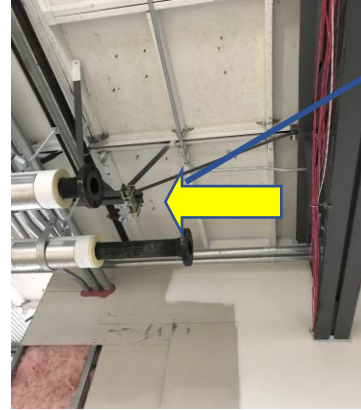
Lines that were connected by loop of piping for flushing

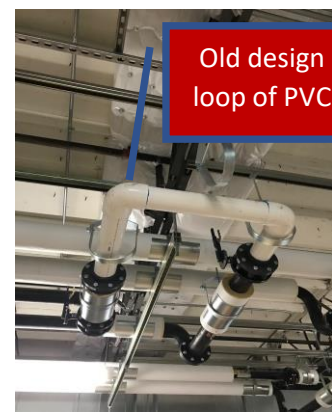
Old design loop of PVC

- Change in temperature caused a component failure.
- Drains had been covered, and open penetrations to lower level allowed water to go directly into an electrical panel.

- Change of loop materials from PVC to copper to eliminate potential for fractures or glue joint failure at higher temperatures.
- Assure available floor drains are open for potential necessary use, and verify hole penetrations near these activities are covered or properly filled.

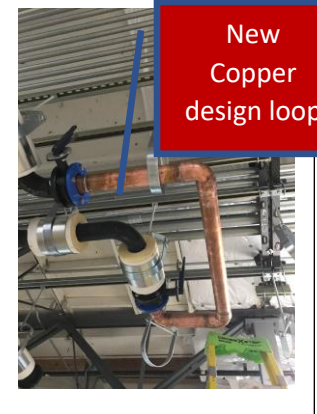
New Copper design loop
