# Lessons Learned

Project: OFA Upgrade

Incident Title: Presslok Fitting Failure

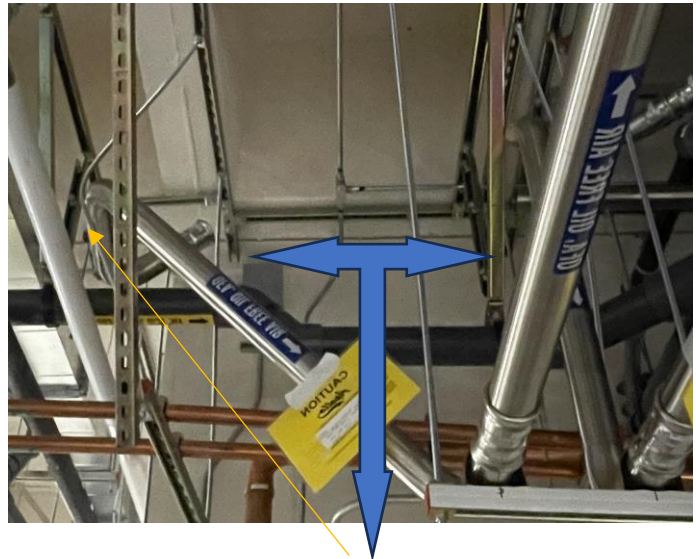
While performing a pressure test on a 3" OFA (Oil Free Air) system in the building, a Presslok joint failed causing an immediate and uncontrolled discharge of argon. Pressure in the line at the time of discharge was approximately 140 psi. The final test pressure would be 165 psi.

All thread stopped the falling pipe from hitting existing lines.

- The team did not follow the process. The go – no go gauge was not used prior to using the Presslok tool.
- The team ran into difficulties and didn't stop the project.
- The team chose to use the MEWP for access which was a change from the original plan of using scaffolding.
- During Pressurization of the system, there was no indication of a leak or loss of pressure before the pipe blew apart.

- Follow the procedure and use the proper equipment to ensure pipe is correctly installed before using the Presslok tool.
- The team should have stopped the work when they realized that they had a tough time reaching the joint.
- Communicate with QA/QC when you're using the Presslok tool to have them spot check the system.
