Lessons Learned

Project: Shipping and Receiving

Incident Title: Multiple Vehicle Accident – Apollo Towing Trailer

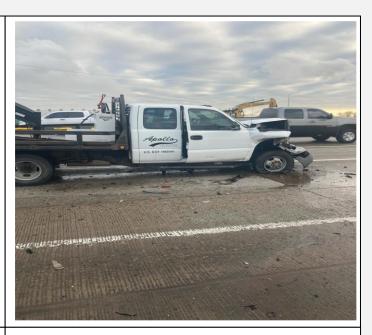
An Apollo driver was driving an Apollo truck attached with a trailer, hauling a forklift to a project. The employee was suddenly cut off by another vehicle rapidly changing lanes ahead of them, blocking sight of traffic ahead that was stopping. Upon being able to see the traffic ahead, the employee attempted to stop, but did not have the proper clearance to come to a stop before hitting the vehicle ahead. Striking the vehicle ahead, caused that vehicle to push into another vehicle, resulting in a multiple vehicle accident.

- Proper follow distances were not allotted regarding the truck length and weight being hauled.
- Employee was distracted by the vehicle that cut them off while also blocking the view ahead that traffic was stopping.

- According to FMCSA (Federal Motor Carrier Safety Administration Large trucks need additional space between vehicles to allow for safe braking and unexpected actions. Trucks pulling trailers should attempt to maintain a minimum distance of 500 ft behind vehicles ahead.
- - If driving below 40 mph, one second should be added between vehicles for every 10 ft of vehicle & trailer length. For speeds over 40 mph, an additional second between vehicles should be given.
- The average stopping distance for a loaded tractor-trailer traveling at 55 mpg (in ideal conditions) is 196 ft., compared with 133 ft. for a passenger vehicle.
