Lessons Learned

Project: Hitachi BaT

Incident Title: Gradall vs Rollup door

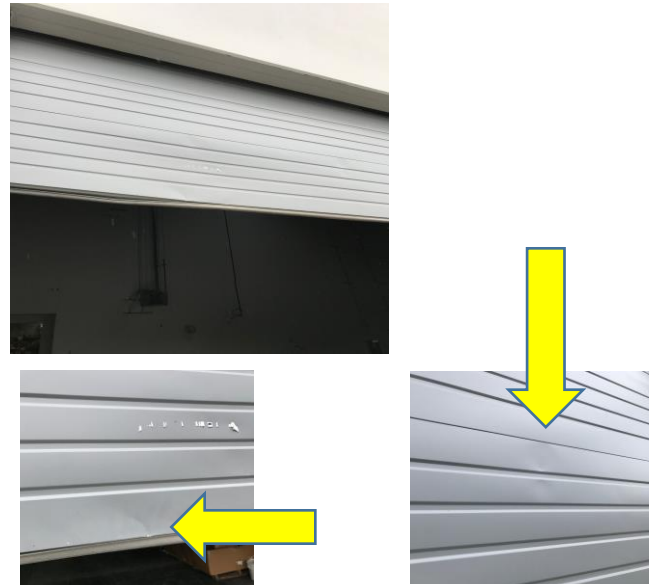
The backrest of the gradall struck the bottom panel of the rollup door causing minor damage to the lower 2 sections.

- Operator misjudged how close he was to the door.
- Operator was trying to boom out prior to lowering the load to deliver the pallet.
- No one was there to receive the delivery, and no spotter was present.

- Utilize spotters.
- Do not operate any controls of a lift without full visibility of where you are going or have a spotter.
- Deliver materials to other personnel whenever possible, so that materials can be moved out of operating doors and into work areas without delay.
