Lessons Learned

Project: Trios Tower Expansion

Incident Title: AHU-4 Frozen Chilled Water Coil

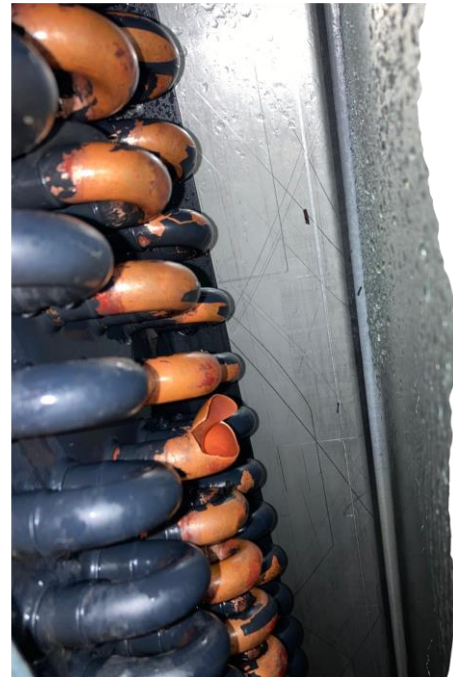
On 2.2.22, the Apollo team onsite put water to the unit, and upon doing so discovered that there were multiple cracks to both chilled water coils in the unit.

- Water was trapped in the coil after the gravity-fed drain down process was complete and froze as the unit sat through the winter not in use.
- Coils were not blown out with compressed air, only drained out at the low points

- The cracks in the coils were discovered before the space and unit were turned over, meaning there would be no impact to the owner's occupation of the space.
- The Apollo team formulated a plan for replacement of the coils and were able to have new coils built and delivered in 2 weeks.

- You cannot trust that a coil will gravity drain. There are too many bends in a coil which increases the possibility of water getting trapped during the drain down process.
- Always drain and then blow out your coils with compressed air, no matter what time of year it is.
- Train your crews on proper winterization. You may not be the one performing this operation and every member of the Apollo team needs to know proper winterization procedures.
