# Lessons Learned

Date:	7/13/2022	Region:	Mountain
Project:	SCL West	Incident Title:	Can You Tell This Is Secure?

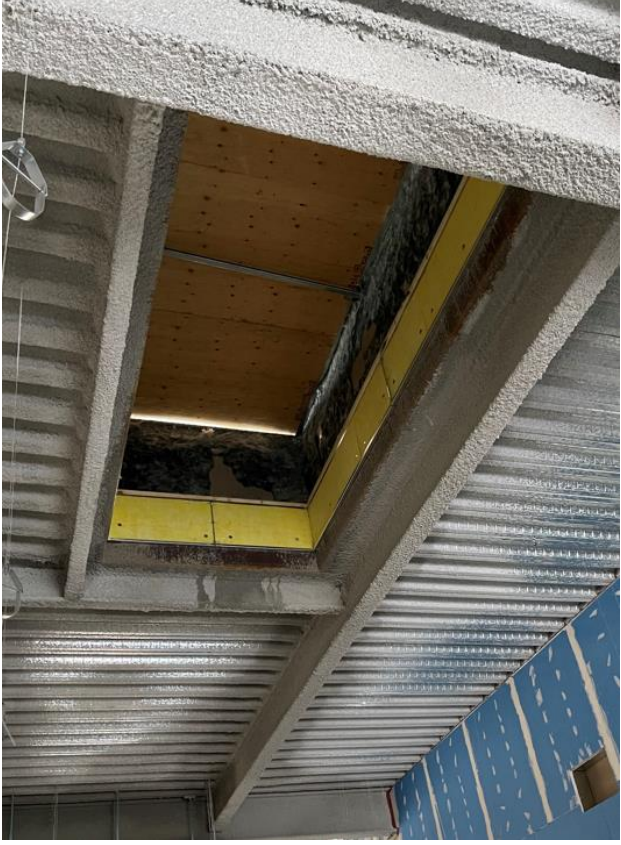
Summary	Picture
<p>An Apollo employee, new to the site, was working overhead, cleaning insulation from an above curb. The employee was not involved with the initial curb install but had noticed Unistrut was placed between the curbing to hold it upright. The Unistrut was not secure, unbeknownst to the employee, so when pressure was applied to the curb, the Unistrut between became loose and fell, striking the employee in the face.</p>

What Went Right?	What Went Wrong?
<ul style="list-style-type: none"> <li>Employee was wearing all PPE saving his head from being struck.</li> <li>Reported immediately</li> <li>Being in lift and tied off prevented the employee from falling further after being struck overhead.</li> </ul>	<ul style="list-style-type: none"> <li>Unistrut was not fastened or secured, either being forgotten or an oversight on management's part.</li> </ul>

Lessons Learned
<p>Can you tell this is secure? All overhead materials and equipment must be secured and fastened, and it must be verified by management that it has been. All overhead hazards must also be barricaded with a limited access zone and warning signs to notify employees of the overhead hazard.</p>
