Lessons Learned

Date: 8/29/2023 Region: National Projects - Oak Ridge, TN
 Project: UPF V-154 Y-12 Incident Title: Sprain/Strain/Wrist (Drill Kickback)

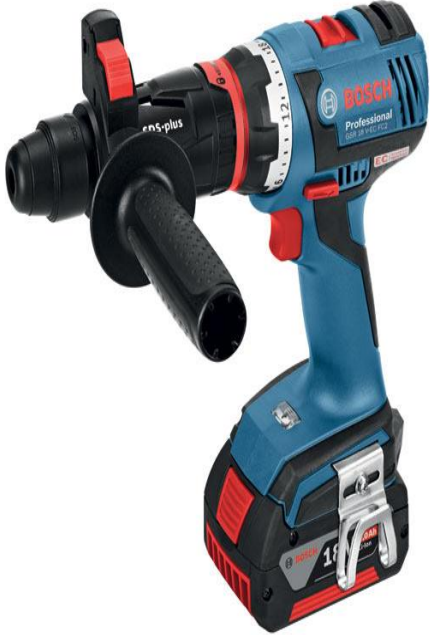
Summary	Picture
<p>Employees were drilling holes in a stainless-steel flange to connect the duct work. They had a plan to drill pilot holes and move up in size to get to the desired 9/16 size needed. In the process, on one of the holes being drilled, the drill bit bound up causing the bit to stop and the employee to lose some control of the drill and spinning his hand and wrist around causing some pain. Employees reported to the supervisor right away and the all the appropriate calls were made to get the employee to the onsite medical team. Employee received ice and was released back to work without restrictions.</p>

What Went Right?	What Went Wrong?
<ul style="list-style-type: none"> • Employees were wearing all required PPE. • Employee reported to supervisor immediately. • The team responded by making all appropriate calls and getting employee to site medical. • No injury was sustained. • All handles were on the equipment being used. 	<ul style="list-style-type: none"> • Employee was not holding the drill tight enough. • The drill got to a bad angle by employee causing it to bite and stop. Ergonomics/body positioning. • 5 common causes of power drill injuries <ol style="list-style-type: none"> 1. Inattention of the user 2. Unexpected interruption while working 3. Inexperience of the user 4. Over confidence of the user 5. Faulty design

Lessons Learned	
<ul style="list-style-type: none"> • When drilling stainless flanges assess the situation and see if there is a better way to perform the work? • Using the correct tools for the application, (Cone) or Step bit possibly. • A punch should be used in this application. • Always use a drill equipped with a clutch and or kickback feature.
