Lessons Learned

Project: V-Fab shop

Incident Title: **Grinder Strikes Again, Causes 3" Laceration**

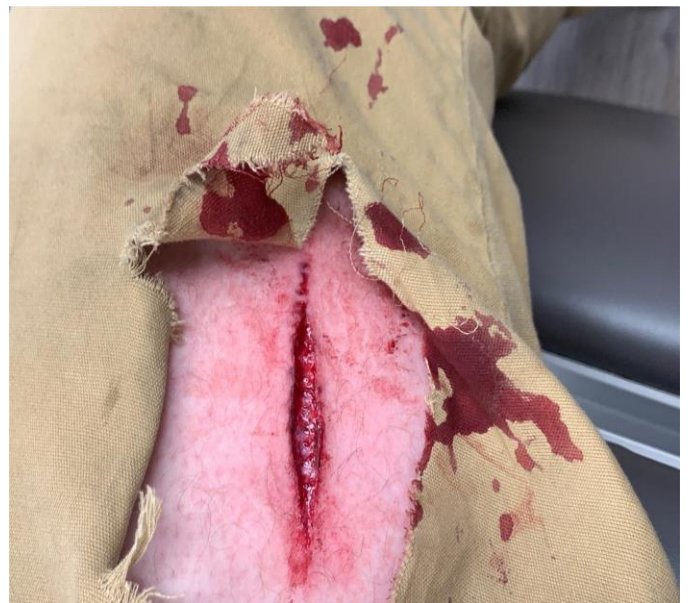
Employee was utilizing a DeWalt heavy-duty grinder equipped with cut-off grinding wheel to prepare some angle iron to be welded. Employee was holding the grinder with both hands and the grinder kicked back, the force of the kick back caused the grinder to hit the employee in the left thigh causing a 3' laceration. Employee was taken to On-Scene Medical and received 8 stitches before returning to work.

- Not inspecting tools and equipment before use, the employee would have noticed the rotation was in the wrong direction.
- Complacency in everyday tasks that we perform.
- Poor body placement while grinder was in use.

- **Complacency! The silent Killer. Never take tasks for granted even the simple tasks that are performed every day.**
- **Always inspect your tools and equipment before each use to ensure they are in good working order and the tool is the correct tool for the task. When using hand tools, keep your hand and wrist in a neutral or "natural" position as much as possible. Don't force your hands or wrists into awkward postures just to fit the tool or the work.**
- **Stay alert, never put yourself in the line of fire. (Body Placement)**
