Lessons Learned

Project: Caldera High School

Incident Title: Un-secured bolt

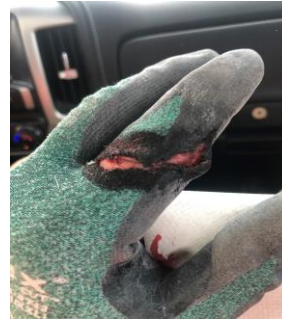
Employee was holding the bracket in his left hand, holding the portaband with the right. His follow-through when cutting the bolt allowed the sawblade to contact his left index finger, causing a laceration that needed 7 stitches to close.

Correct positions for 2 hands on tool

Bolt to be cut off

Securing materials in a vice would have allowed employee to properly use the tool. Thereby eliminating the line of fire positioning of his index finger, less than 2 inches away from a moving blade. There was no need to do this task this way.
