# Lessons Learned

Project: Rocky Mountain Lab

Incident Title: Broken procedure, broken pipe

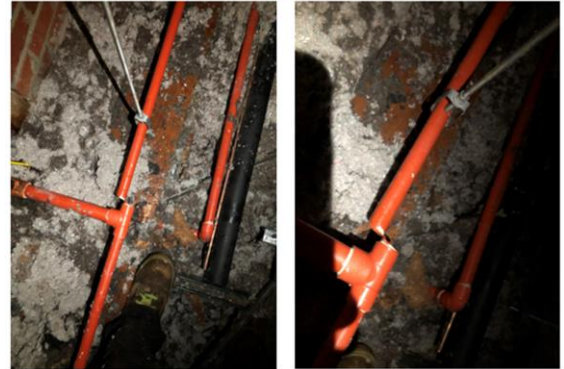
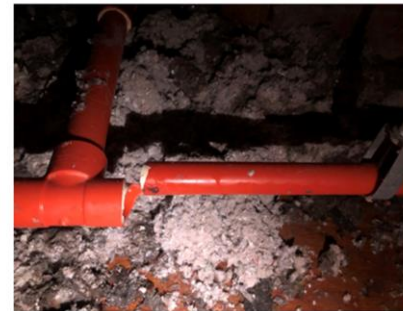
Employee was working in the attic of Building 8 located on the Rocky Mountain Lab, installing an electric air filter on the attic furnace. In the process the employee was working adjacent to an active CPVC fire sprinkler piping. While removing the pleated filter, the filter became snug and to protect the piping, the employee had one hand on the CPVC pipe and the other pulling out the filter. When the filter gave way, it hit the CPVC at the t-fitting causing the pipe to break, discharging water throughout the space. No one was injured during this incident only facility damage occurred at this time.

- Improper hazard and risk assessment in a tight work environment
- Lack of protection of other piping

- **Bullet proof work area prior to working in the area.**
- **Shutoff system prior to working, if possible, to prevent further damage.**
- **Be aware on any active systems and properly implement the correct working procedures.**
