Lessons Learned

Project: X1325 SMC Bed Tower

Incident Title: Construction Equipment & Public Right-of-way

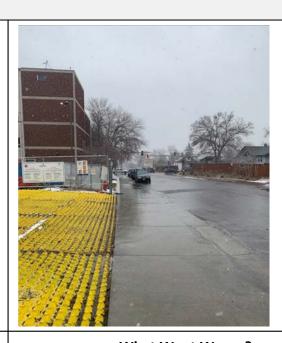
Forklift was being driven from one jobsite laydown yard to another. When pulling out of jobsite, operator seen a car coming down the street and tried to stop. The exit was on a downhill slope, and he was on a plastic mud mat that was slippery and wet from snow. The forklift did not stop but slid down the hill and the forks contacted the moving car.

- Traffic control / flagman assigned to area was on lunch, so relocation of forklift proceeded without traffic control.
- Driver of forklift did not anticipate forklift to slide on mud mat.
- View of street was obscured by signage on jobsite gate and spotter wasn't utilized.

- Be sure forklift safety training includes content on traffic control and what to do if accessing public right-of-way is required.
- Driver of forklift needs to move only when spotter signals okay to do so if unavoidable blind spots exist.
- Refresher training is required every three years and after any incident or observed operator error.
