# Lessons Learned

**Date:** 01/19/2022      **Region:** Seattle  
**Project:** Microsoft  
**Incident Title:** Drain Pipe Sever

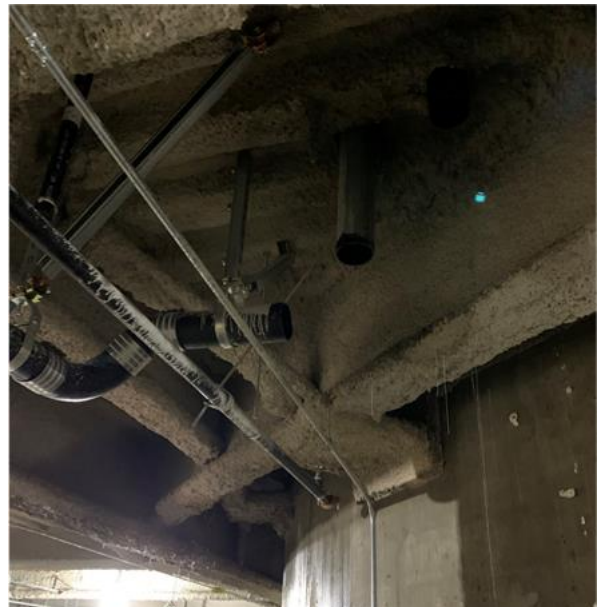
Crew was directed to remove a drain pipe that was incorrectly installed. During removal a portion of the pipe got caught on a riser clamp which was hidden below. This caused the no hub band to slip off the pipe which resulted in a 14.5" piece of pipe to fall to the floor below missing the trash bin placed below.

- Initial drain body installed was not the correct elevation
- Insufficient management of crew and the task assigned
- Foreman did not provide barricades or PTP for the crew

- Develop a PTP template with foreman and safety to ensure PTP is easily available when needed
- Review barricading requirements and ensure that spotter is available when needed
- Ensure that work area is fully inspected prior to starting--even on short notice tasks
