OH Schit...

Division/Project: Denver / At Home Incident

Title: Locking Power Tool Triggers

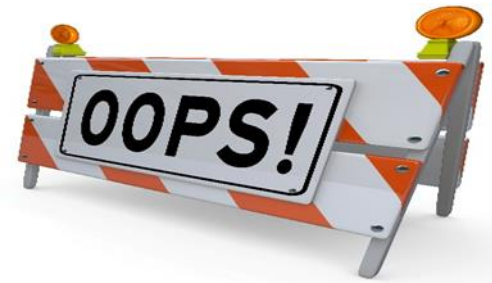
Employee was using corded grinder at home. Older 4" grinder had a locking trigger switch. Grinder was not designed with a "T" handle. The blade bound up and twisted out of employee's hand, landing on employee's foot.

Older grinder was not equipped with a constant-pressure switch that would shut off power when the operator released pressure on the trigger.

- **Advancement in tool technology isn't always realized at home, take inventory now of your older tools and look for newer safety devices that may not be present.**
- **Locking power tool triggers are extremely dangerous, update your tool chest at home, today! STAY HEALTHY – STAY SAFE!**
