# Lessons Learned

**Project:** Tesla Giga Factory – Mop Sink Installation

**Incident Title:** Wrong tool for the job

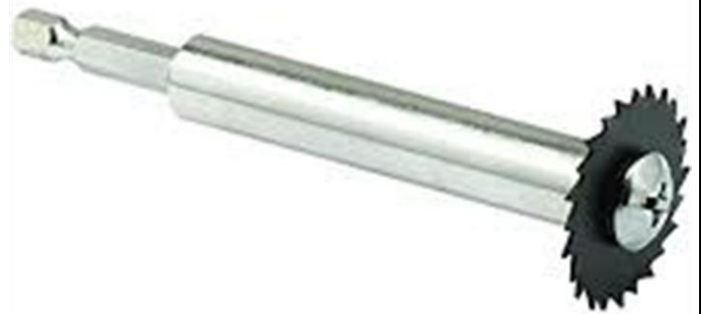
Employee was installing a mop sink. To complete the fit-up of the job, the PVC drainpipe had to be cut to the proper length. Due to the proximity of the pipe and the lack of space at the point of cut, a drill and a saw blade bit was used.

While making the cut, the tool rebounded out of the cut, hit the underside metal portion of the sink and bounced back, causing the blade to contact the surgical glove that was being worn. The saw blade wound the glove around the tool's arbor and pulled employee's right hand into the blade causing a laceration.

- The entire post-accident process needs to be documented, printed and shared with Apollo Team
- The employee used a tool that is designed to cut a PVC pipe from the inside. The process required the pipe to be cut from the outside.
- Potential hazard associated with use of the wrong tool was not identified.

The Pre-task plan should have included the hazards associated with the task to be performed.

Tool available was inappropriate for the task planned and thus created the hazard.

When an unplanned hazard is identified, **Stop Work** and re-adjust your Pre-task plan to mitigate the hazard before you continue with the work.
