Lessons Learned

Project: Arlington

Incident Title: Forklift Pinch Point

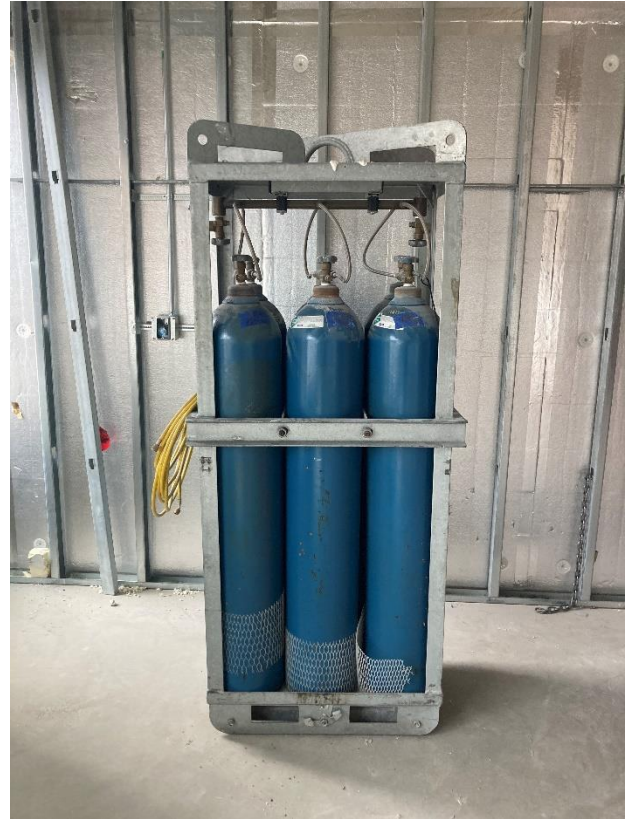
Picture

Two Apollo workers were lowering a Nitrogen 6 pack cylinder cradle from an upper level to the 1st floor. The forks were not spread wide enough to safely lower the load without it shifting.

While lowering the cylinder cradle the load began to sway, the Apollo spotter stuck their arm out to stop it from shifting, and their arm became momentarily pinched between studs to the side of the load and cylinder cradle they were lowering.

- Forklift loads need to be properly supported prior to lifting via adjusting the forks, using straps if necessary, properly centering loads, and using properly stacked/positioned loads
- Spotters should not put their hands in pinch points

- Always ensure that loads are safe for transport prior to lifting
- Prior to lifting, potential pinch points prior shall be identified
- Spotter training shall reinforce that no one is to put their hands into pinch points
