Lessons Learned

Project: Microsoft Rework

Incident Title: Conduit Contact

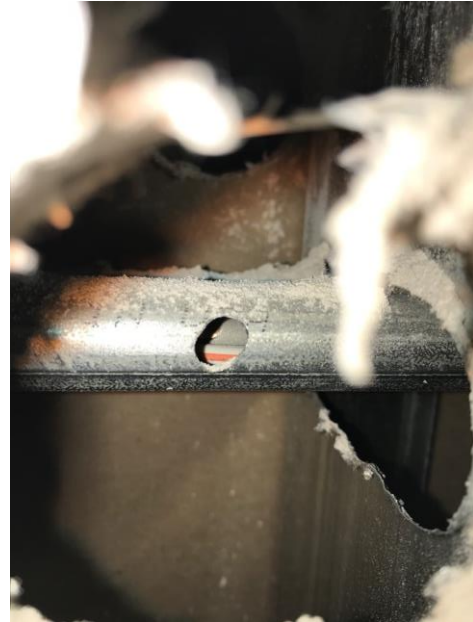
Picture

After laying out the location for the penetration the foremen went ahead and began drilling. They went through the drywall and security mesh and conducted a visual inspection. Following the visual they continued drilling until they felt something out of the ordinary. They noticed their pilot had drilled through conduit. Work was immediately stopped and reported to their lead and electrical subcontractors.

- Pilot bit was too long for the application
- Employee was rushed to complete work for to meet testing date
- Final drawings weren't provided prior to drilling
- Hole could have been made larger for more thorough inspection
- Late internal notification

- Ensure employees have various tools readily available that properly fit the work
- Holidays may lead to rushed schedules, which may result in shortcuts being taken
- Foreman are just as susceptible to complacency
