Lessons Learned

Date: 4/18/2023 Region: Oak Ridge Tn.

Project: UPF V-154 Y-12 Incident Title: Near Miss Smoldering Rag

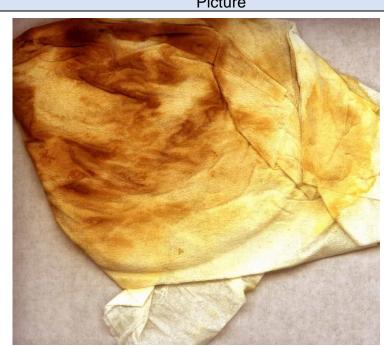
Summary Picture

While setting up a welding operation in the morning the task was moved to a different location within the barricaded work area. Upon completion of the initial hazard assessment, the crew went to lunch.

After lunch the crew returned to the work area, resumed their weld preparations, then started welding. While on lunch break a cart was placed within their barricaded work area. When the crew started welding, some sparks fell on to the cart and a rag that was on the cart. The rag began to smolder and smoke.

- The crew did not walk down and re-evaluate the work area for hazards or changed conditions after returning from lunch.
- Area was congested with Knaack boxes that should have been moved.
- Firewatch did not position himself to allow a full view of the complete area where the sparks were falling.

- Called immediate safety stand down to discuss the reassessment of work areas after breaks and lunch.
- Discussed the fire watches placement in the area to be able to see all potential hazards.
- Retrain fire watches about hazard awareness. Continuous Improvement on evaluation of the work areas.
- Conducting more frequent audits of the hot work areas.
